CASE STUDY

3-Alarm Disaster of a Detention Pond Gets Remediated

Fixing Standing Water and Slope Erosion Issues

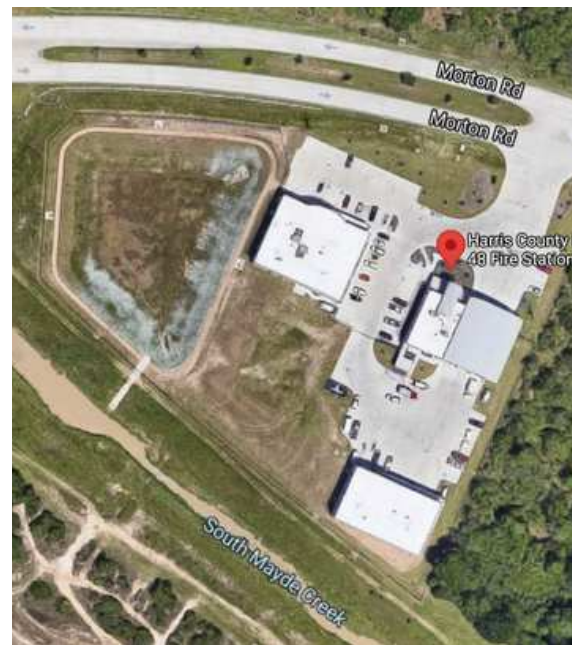
- Sediment and vegetation build-up in bottom of the pond, resulting in constant standing water and maintenance difficulties
- Poor stabilization causing erosion problems on slopes
- The path around the top of pond, often used for walking/running by the fire station's personnel, was eroded and no longer useable or safe.

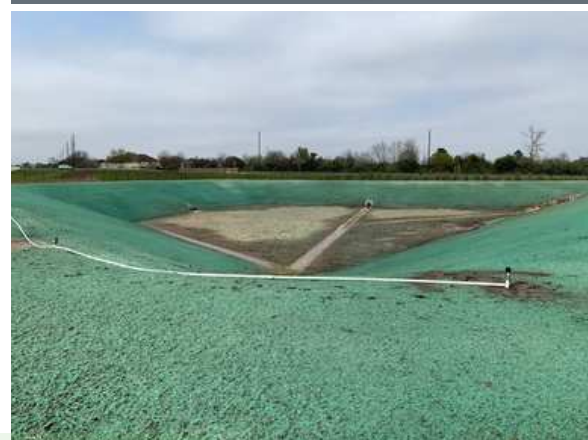
Today, as the images show below, the pond is compliant with a healthy stand of grass from top to bottom and is operating at expected levels.

- Remove debris and existing decomposed granite path along pond bank
- Regrade the bottom of the pond and the slopes
- Install a 192’ drainage pilot channel
- Install Grass Cell reinforced path along pond bank
- Soil test and recommended amendments
- Hydraulically applied ProGanics (all) and Flexterra (slopes only)
